Appendix A – CCC Engineering Assessment (Miyamoto Cardno)

Subject: Christchurch Cathedral "Make Safe" Prior to Reconstruction

Appendix - Summary of the damage to the Cathedral

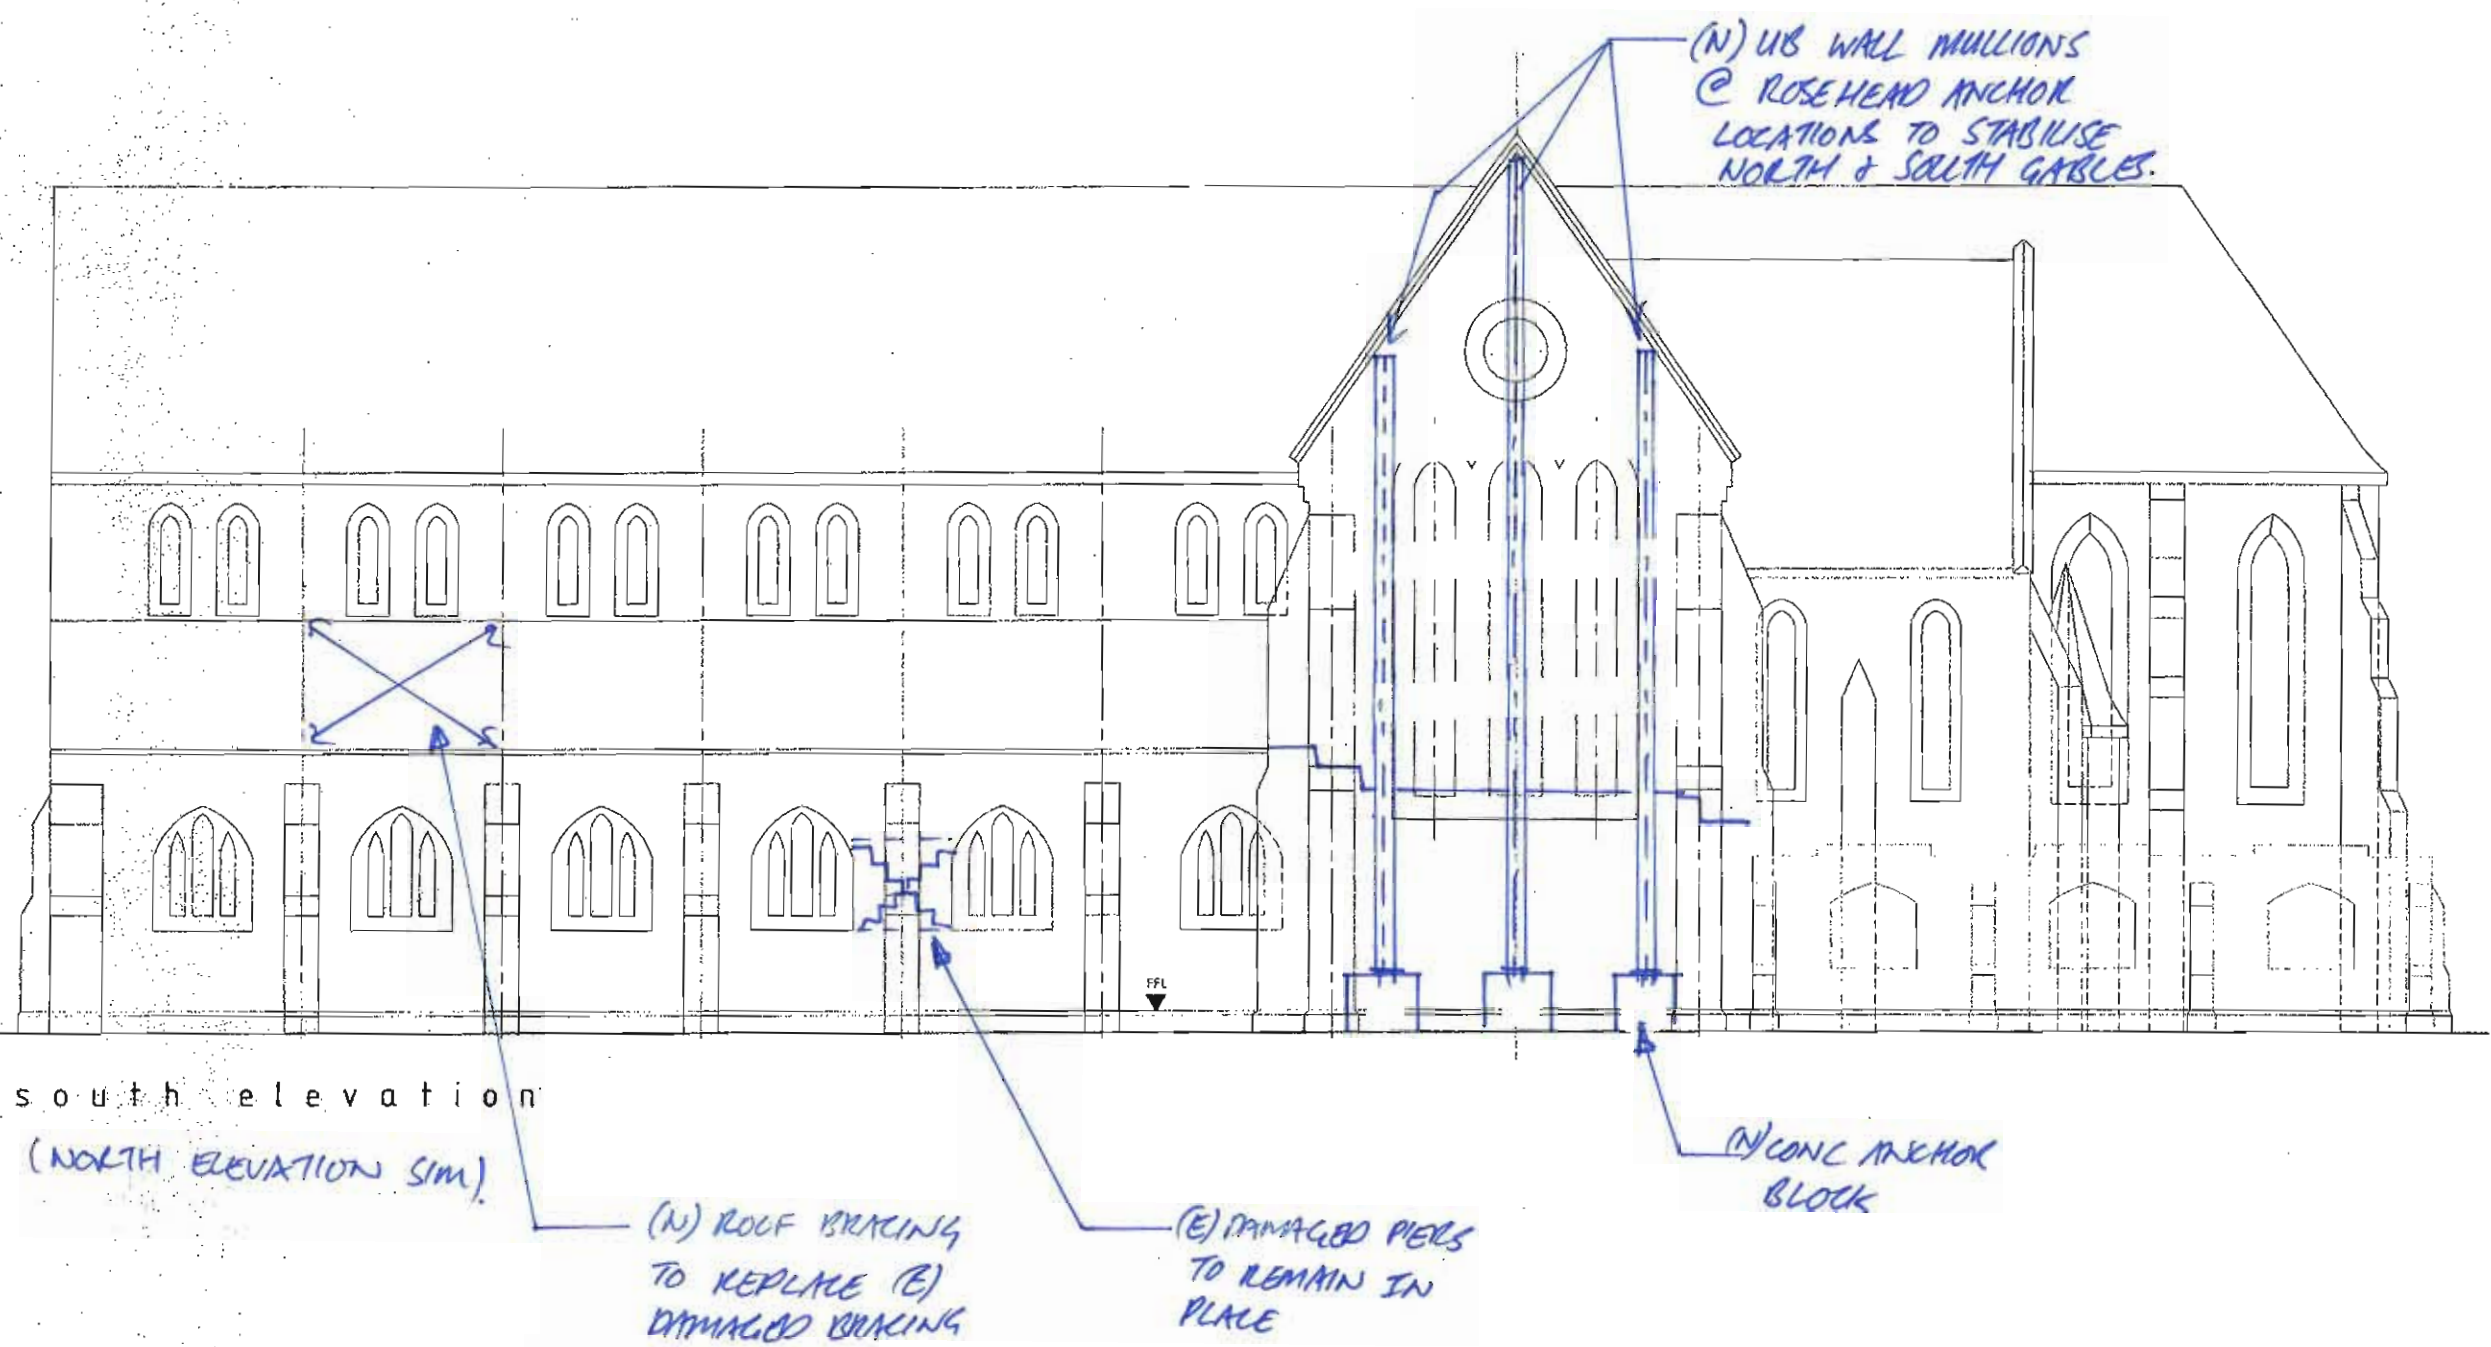
South elevation
(North elevation sim.)

(E) DAMAGED PIERS TO REMAIN IN PLACE

(N) ROOF BRACING TO REPLACE (E) DAMAGED BRACING IN THIS BAY.

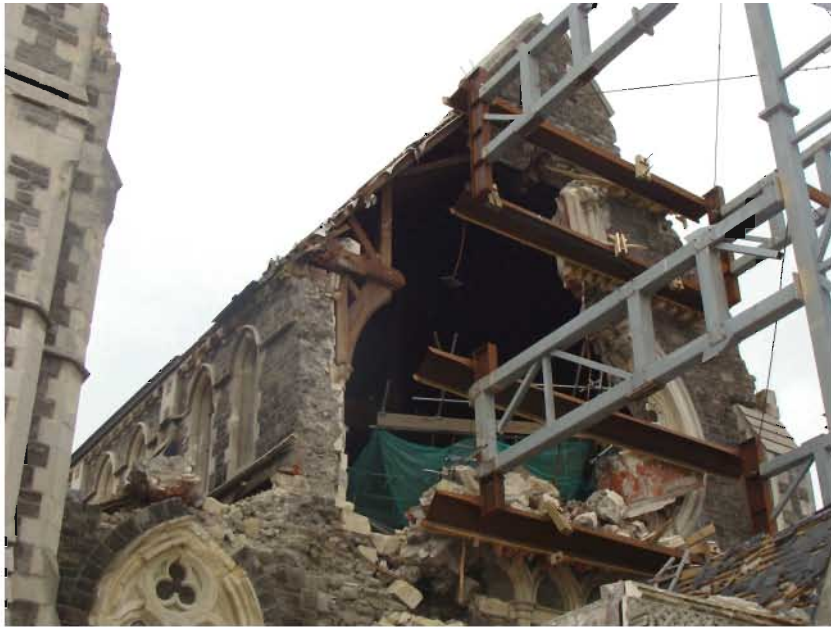
West wall 22nd September

It is clear from the above photo's that the damage has not progressed over the six week period between photo's. In addition, I have liaised with stonemasons from Stoneworks who have been clearing the rubble from in front of the West wall. Under their health and safety assessments, they have monitored the works on a daily basis and have informed us that no movement has taken place. The West wall is the most damaged area of the Cathedral and is likely to be largely deconstructed so any movement of this wall is not considered to be a issue, given that there is a large steel frame protecting the public along with a safety fence some 30m away from the building.

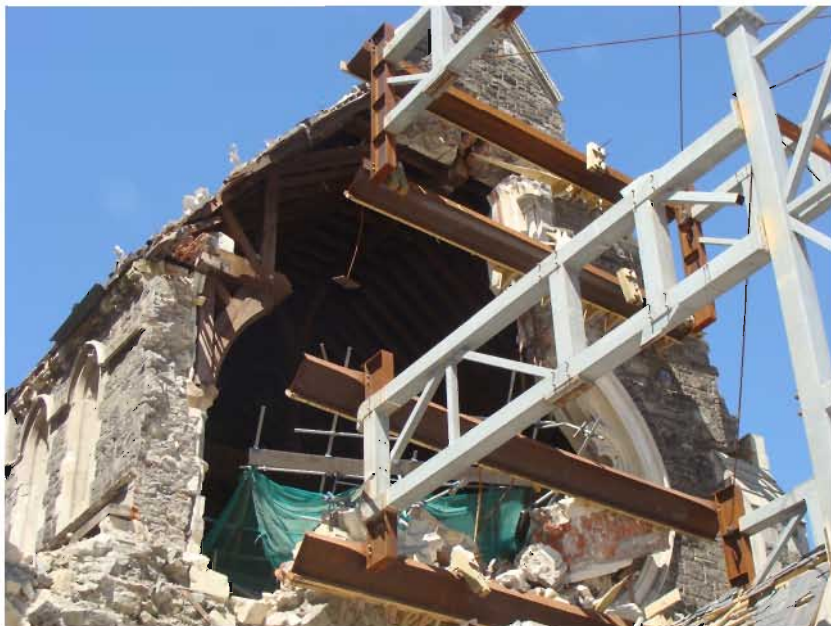
West wall 3rd November

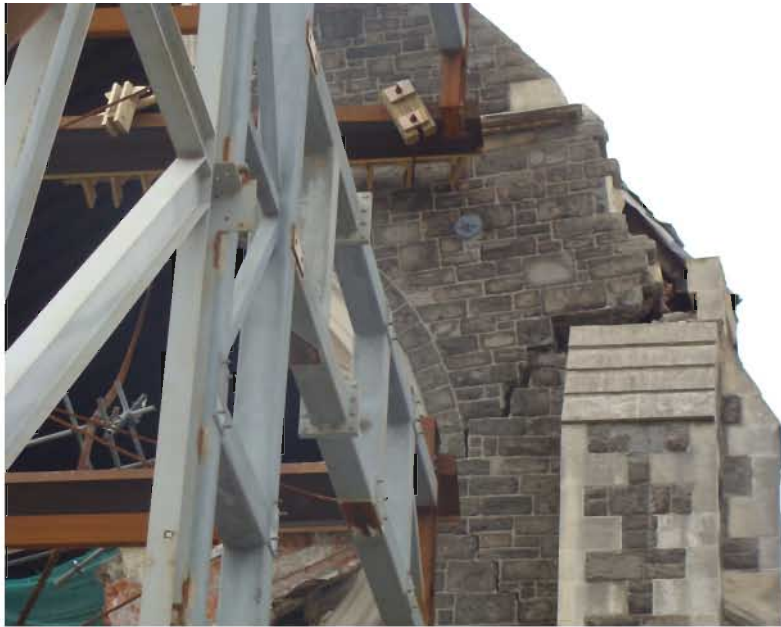
SW corner 22nd September

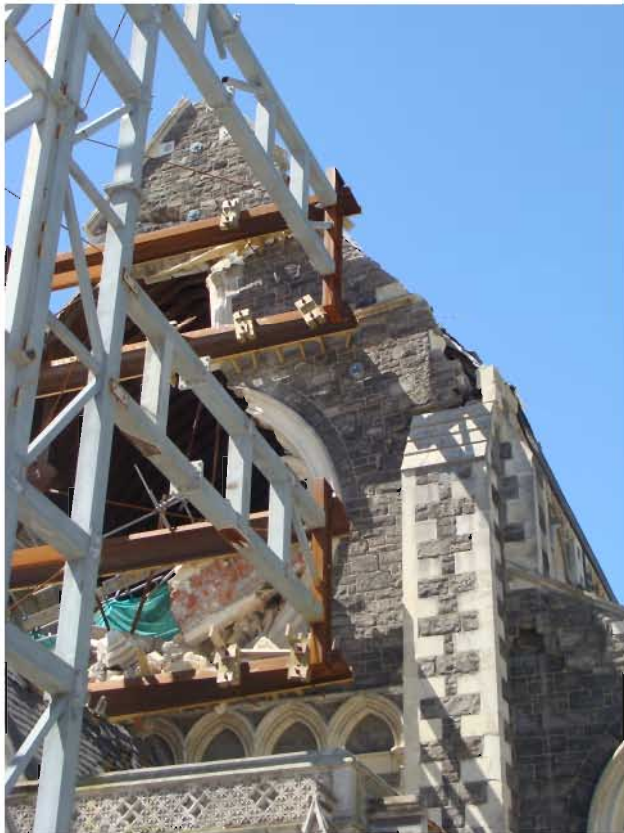
SW corner 3rd November

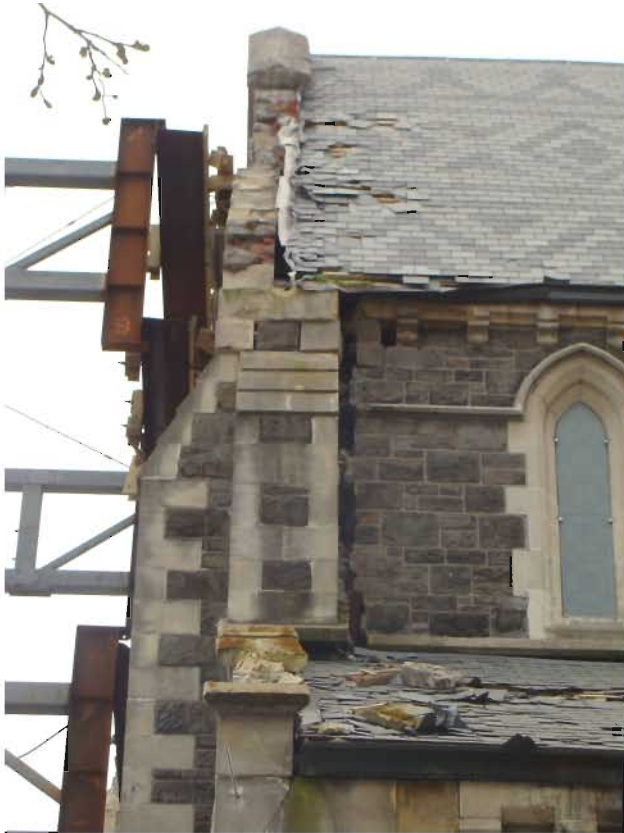
SW corner junction 22nd September

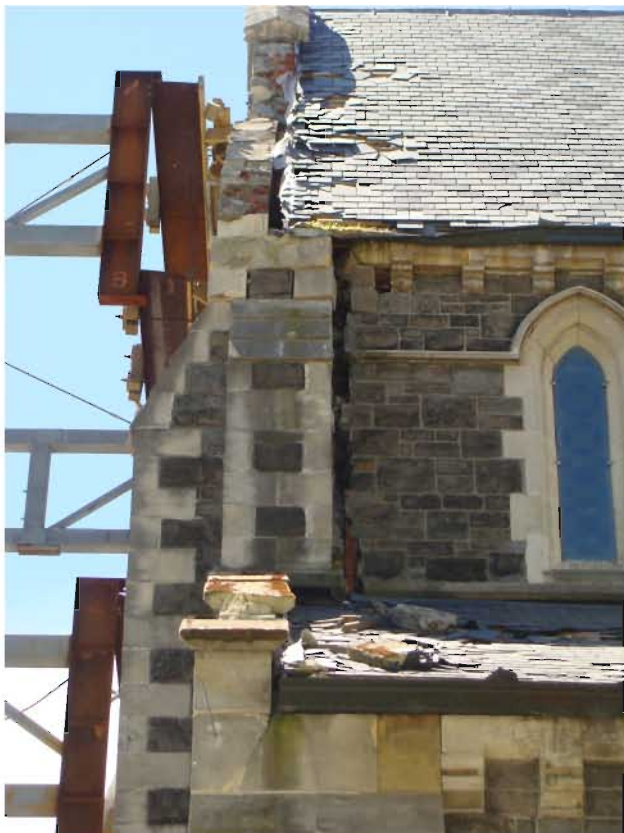
SW corner junction 3rd November

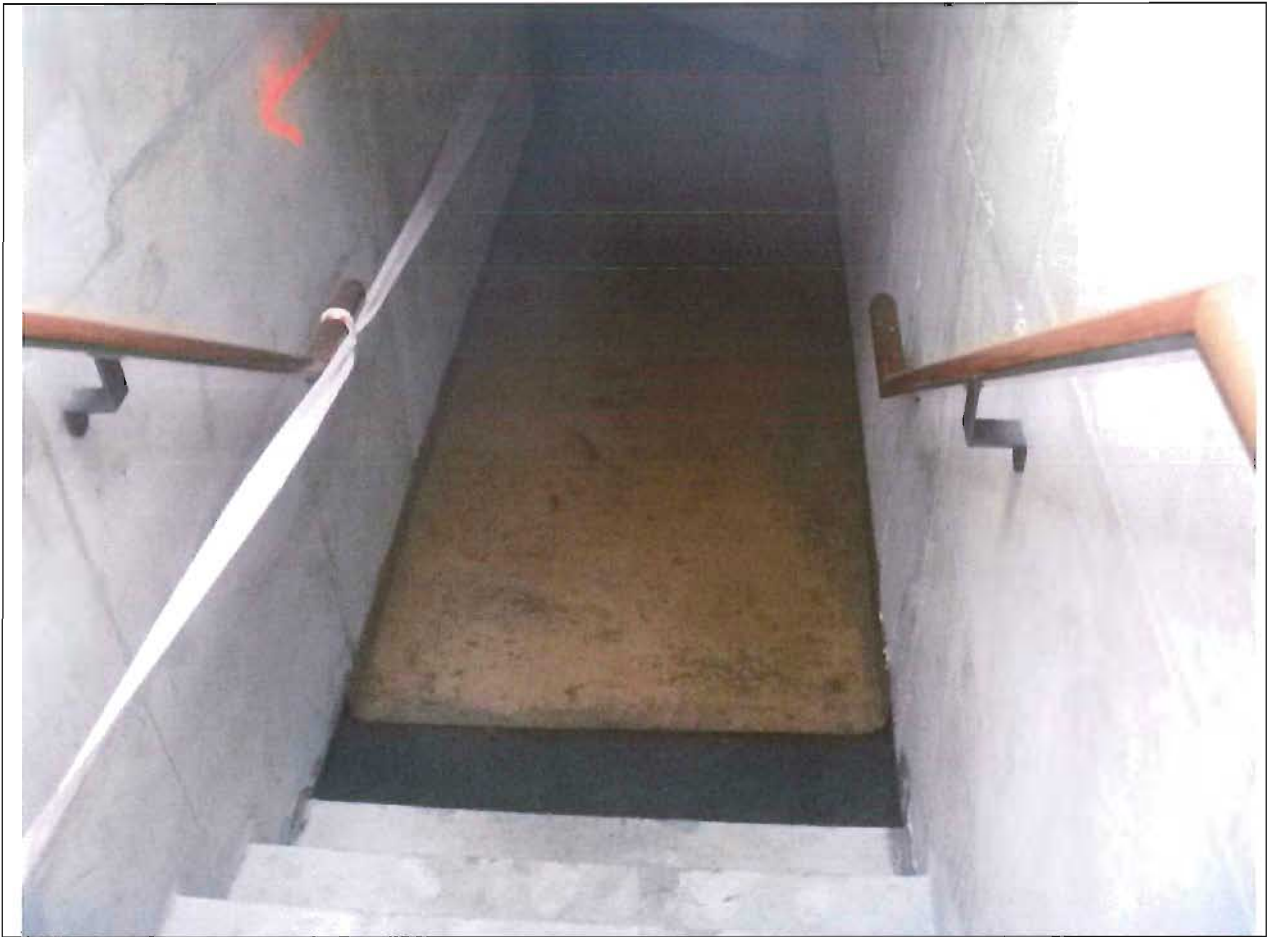
Photograph B - Approximately 100mm depth of water in tunnel

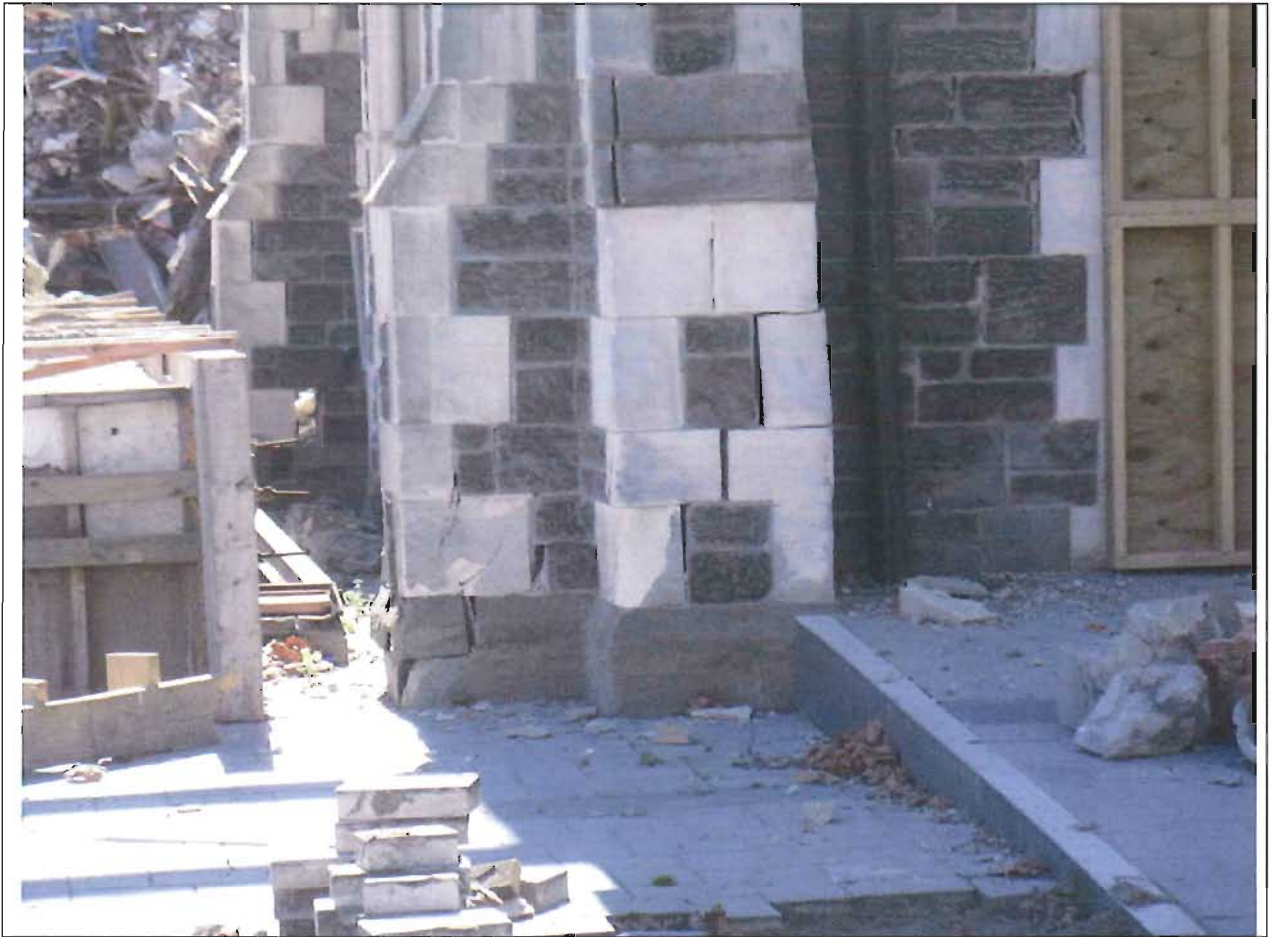
Photograph C – Shaking damage to the top of the foundation at the south west corner of the building

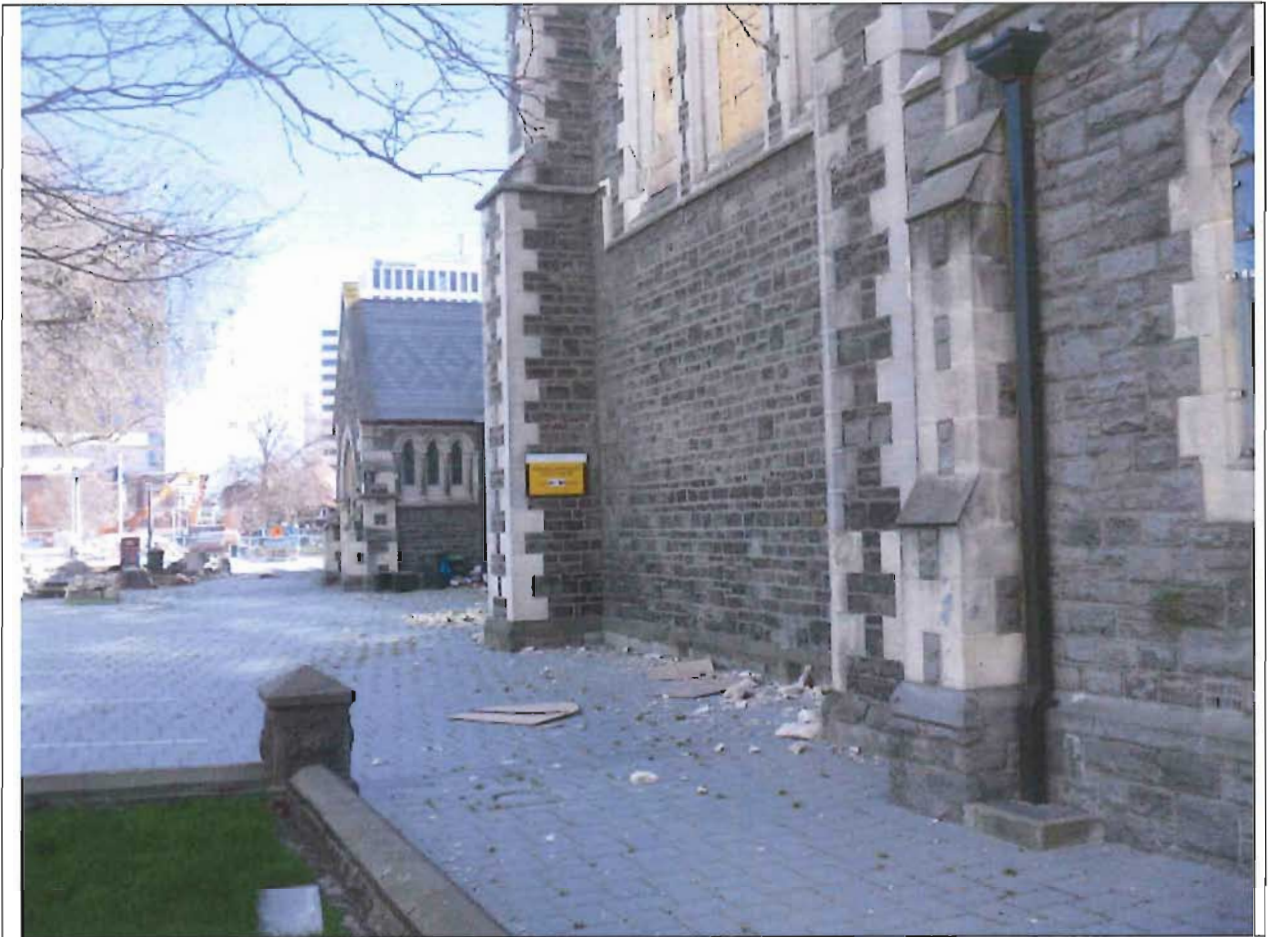
Photograph D – General view of south side of Cathedral showing no liquefaction or ground settlement damage

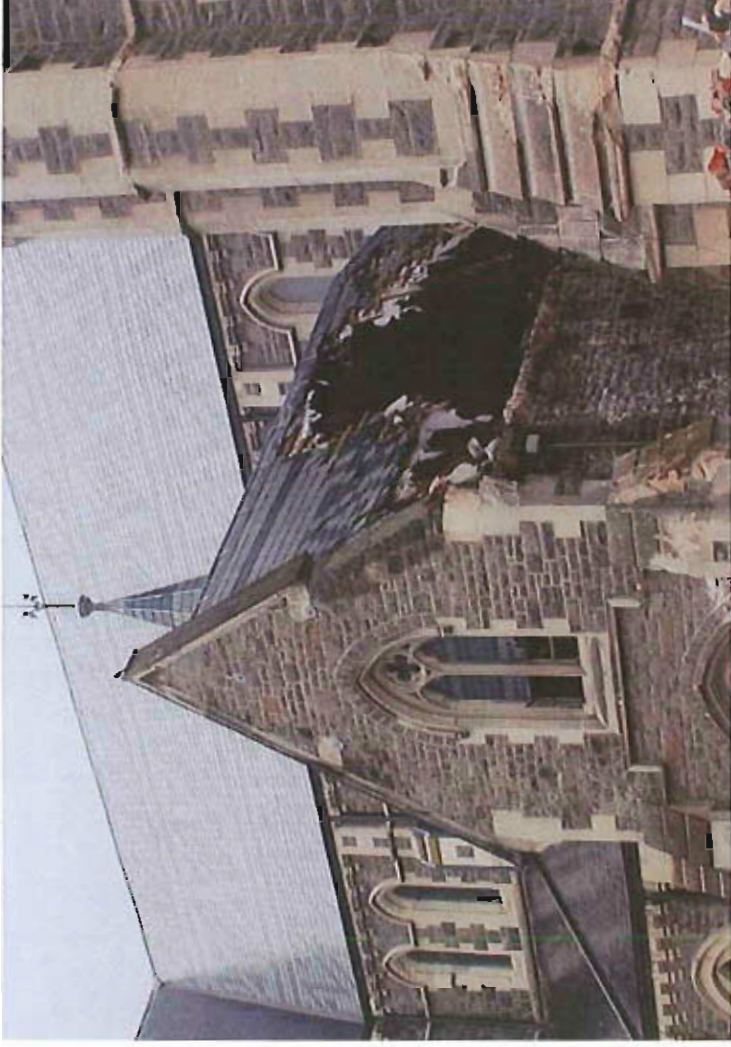
Figure 2 The north porch roof coverings – a principal area of damage to the roof slates.

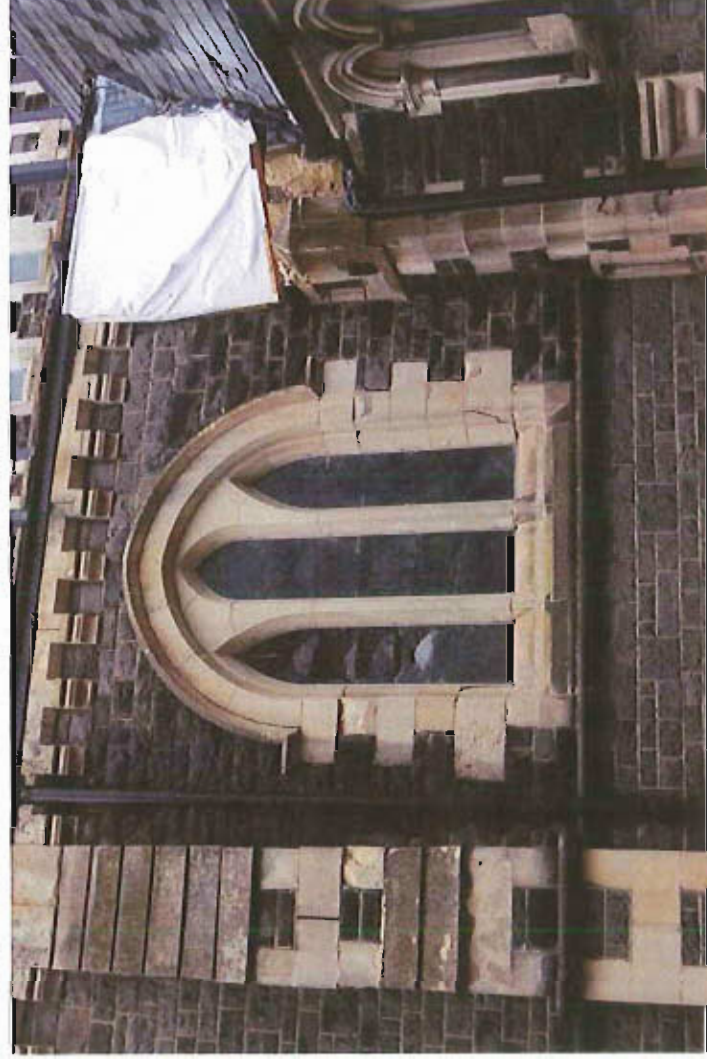
Figure 3 Guttering to the south aisle and porch with water saturation of the wall behind the downpipe indicating a blockage or disconnection.

As part of any future making safe and weatheright works, the drains will need to be investigated and allowance made for their repair or renewal in addition to localised rectification of the rainwater fittings themselves.

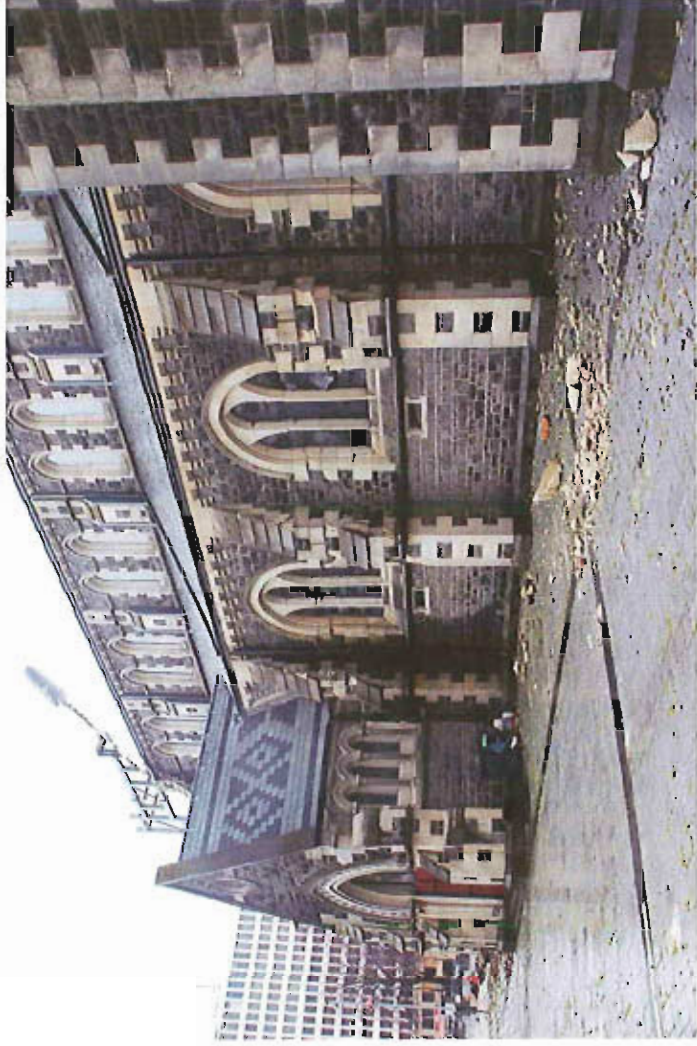
Figure 5 Buckling of the leaded lights to the south aisle windows has occurred, together with loss of the protective glazing, although these windows are capable of repair. Clerestory light above appear to be intact and to have suffered little or no damage.

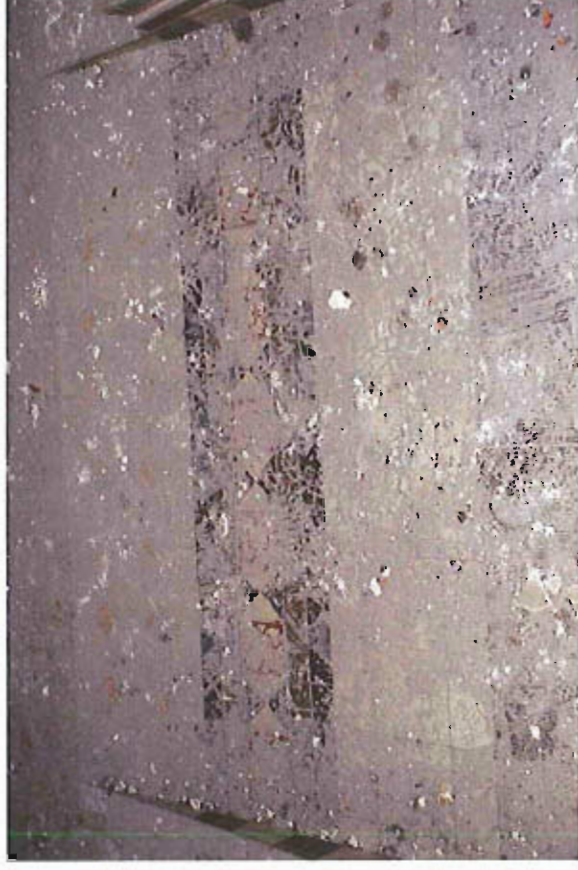
Figure 6 A section of the floor in the south aisle showing the extent of dust and potential for scraps/scuffing of the tiles even where masonry has not fallen

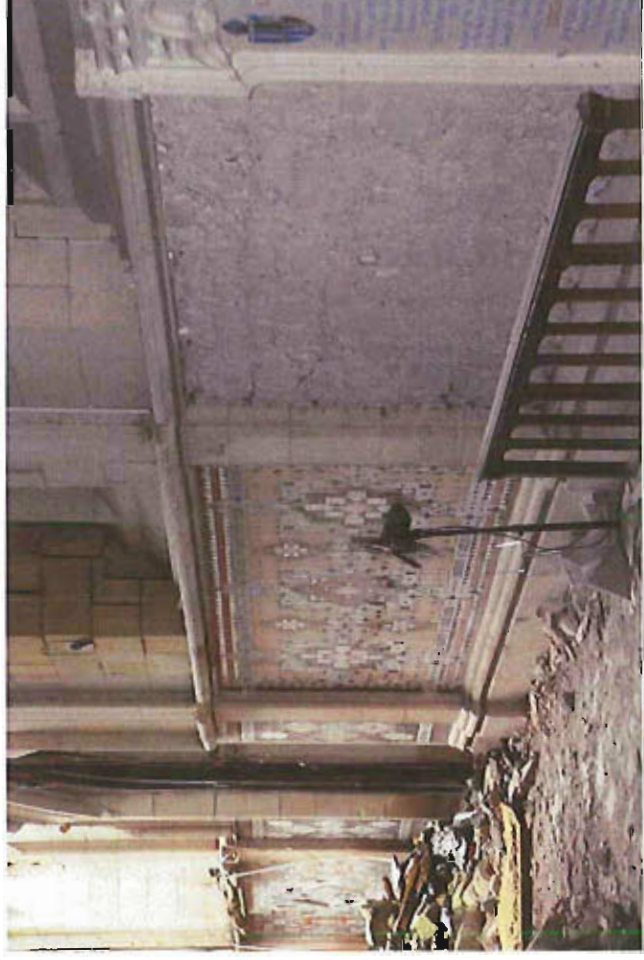
- Geometric/mosaic dado tile panels along the external wall of the south aisle.
A large panel between the doors to the north porch and tower has lost its centre. This can be reinstated either in new matching pieces of tile or by salvage of the fallen pieces (or most likely a combination of the two). Otherwise damage appears to be isolated or non-existent. Note: the section of exposed and white-washed stonework in the picture below is thought never to have been decorated.

Figure 8 Damaged/fallen geometric mosaics to the south aisle.

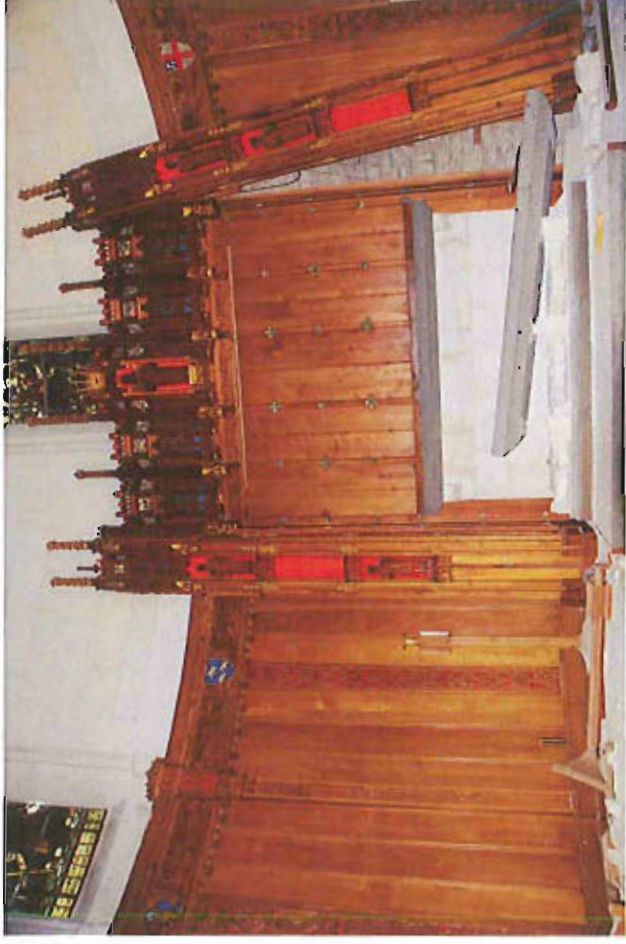
- The altar
The altar table itself has collapsed and a section of the timber panelling to the apse immediately to the south is displaced, although the remainder remains intact.

Figure 9 Collapse of the altar table
