Earthquake and Concert Hall

Takayuki Hidaka
Takenaka R&D Institute

Toronto, Canada
International Symposium on Room Acoustics
2013 June 9-11

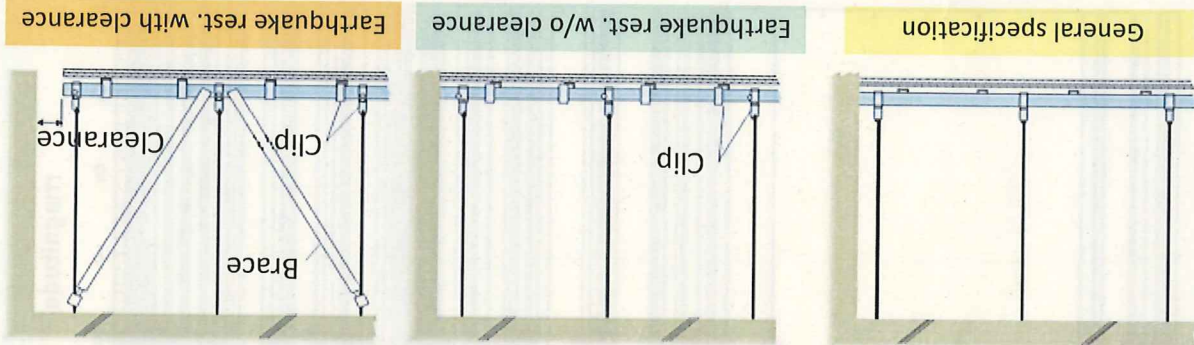
Suspended ceiling system

General specification

Earthquake rest. w/o clearance

Earthquake rest. with clearance

Inertia force by earthquake is absorbed by wall.

Braces restrain horizontal displacement, and clearance protects wall from being touched.

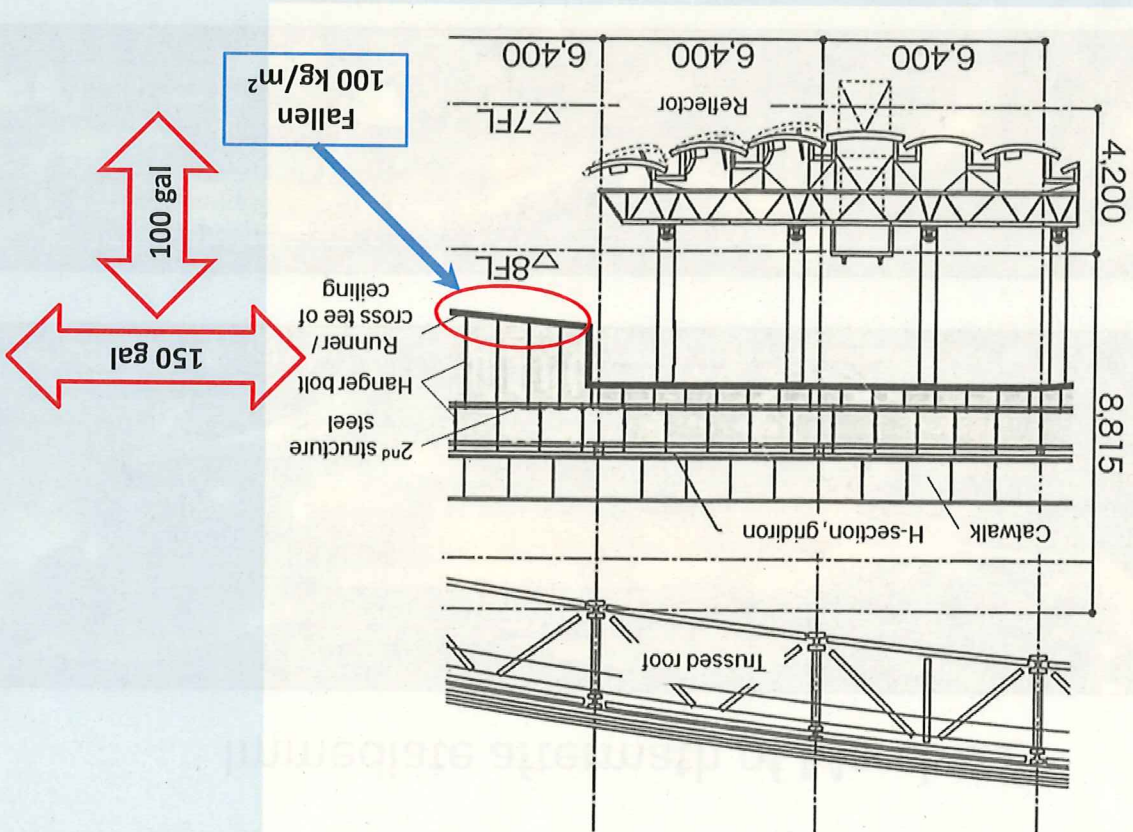
Damaged ceiling

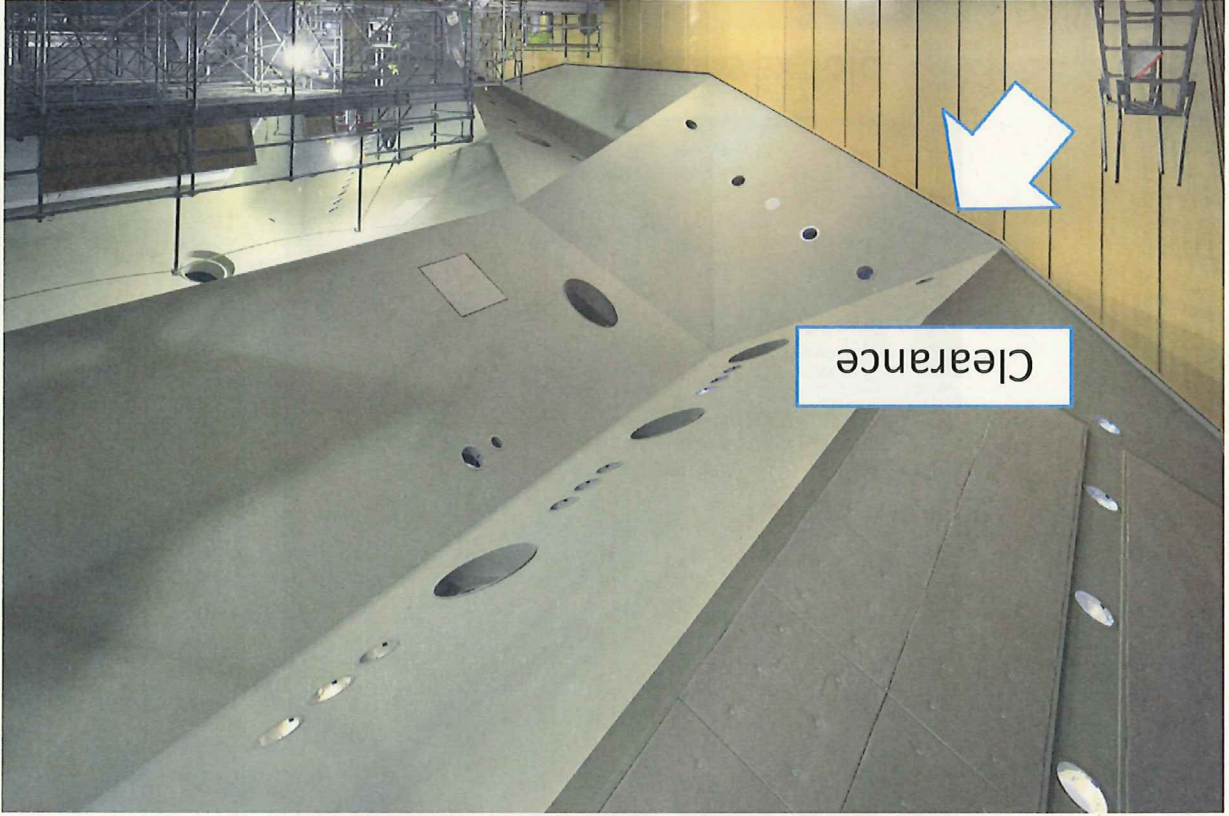
Section of the damaged ceiling.

1. Clearance between ceiling and wall
2. Reinforcement of ceiling support members
3. Reinforcement of convex folds, board joint, etc.
4. Prevention of concentrated loading
5. Same length of hang bolts
6. Prevention of shear disp. of vibration isolator

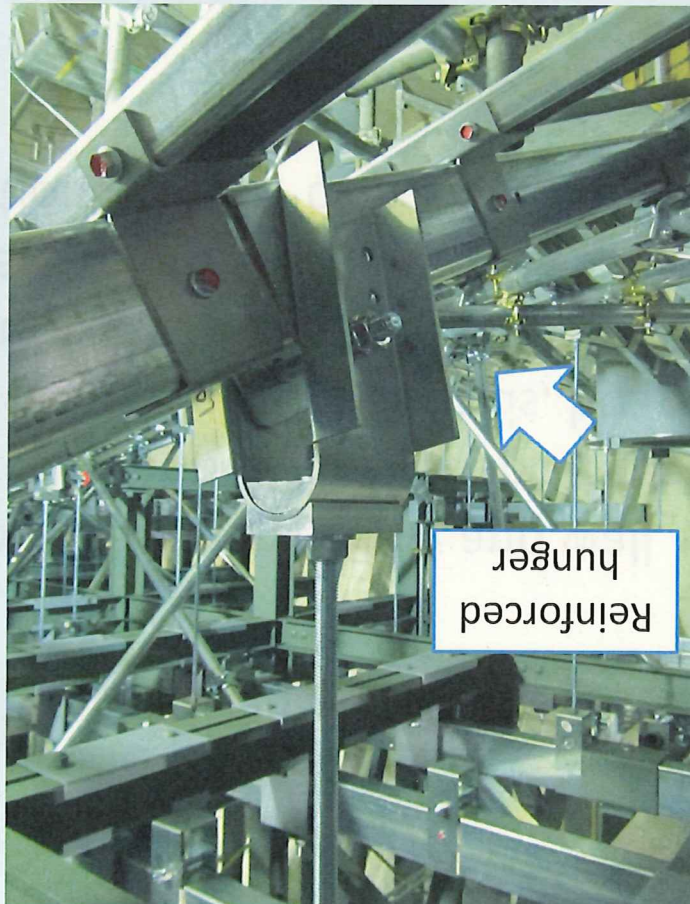
Overview ceiling support system
