Appendix A – CCC Engineering Assessment (Miyamoto Cardno)

Subject: Christchurch Cathedral "Make Safe" Prior to Reconstruction

Appendix - Summary of the damage to the Cathedral

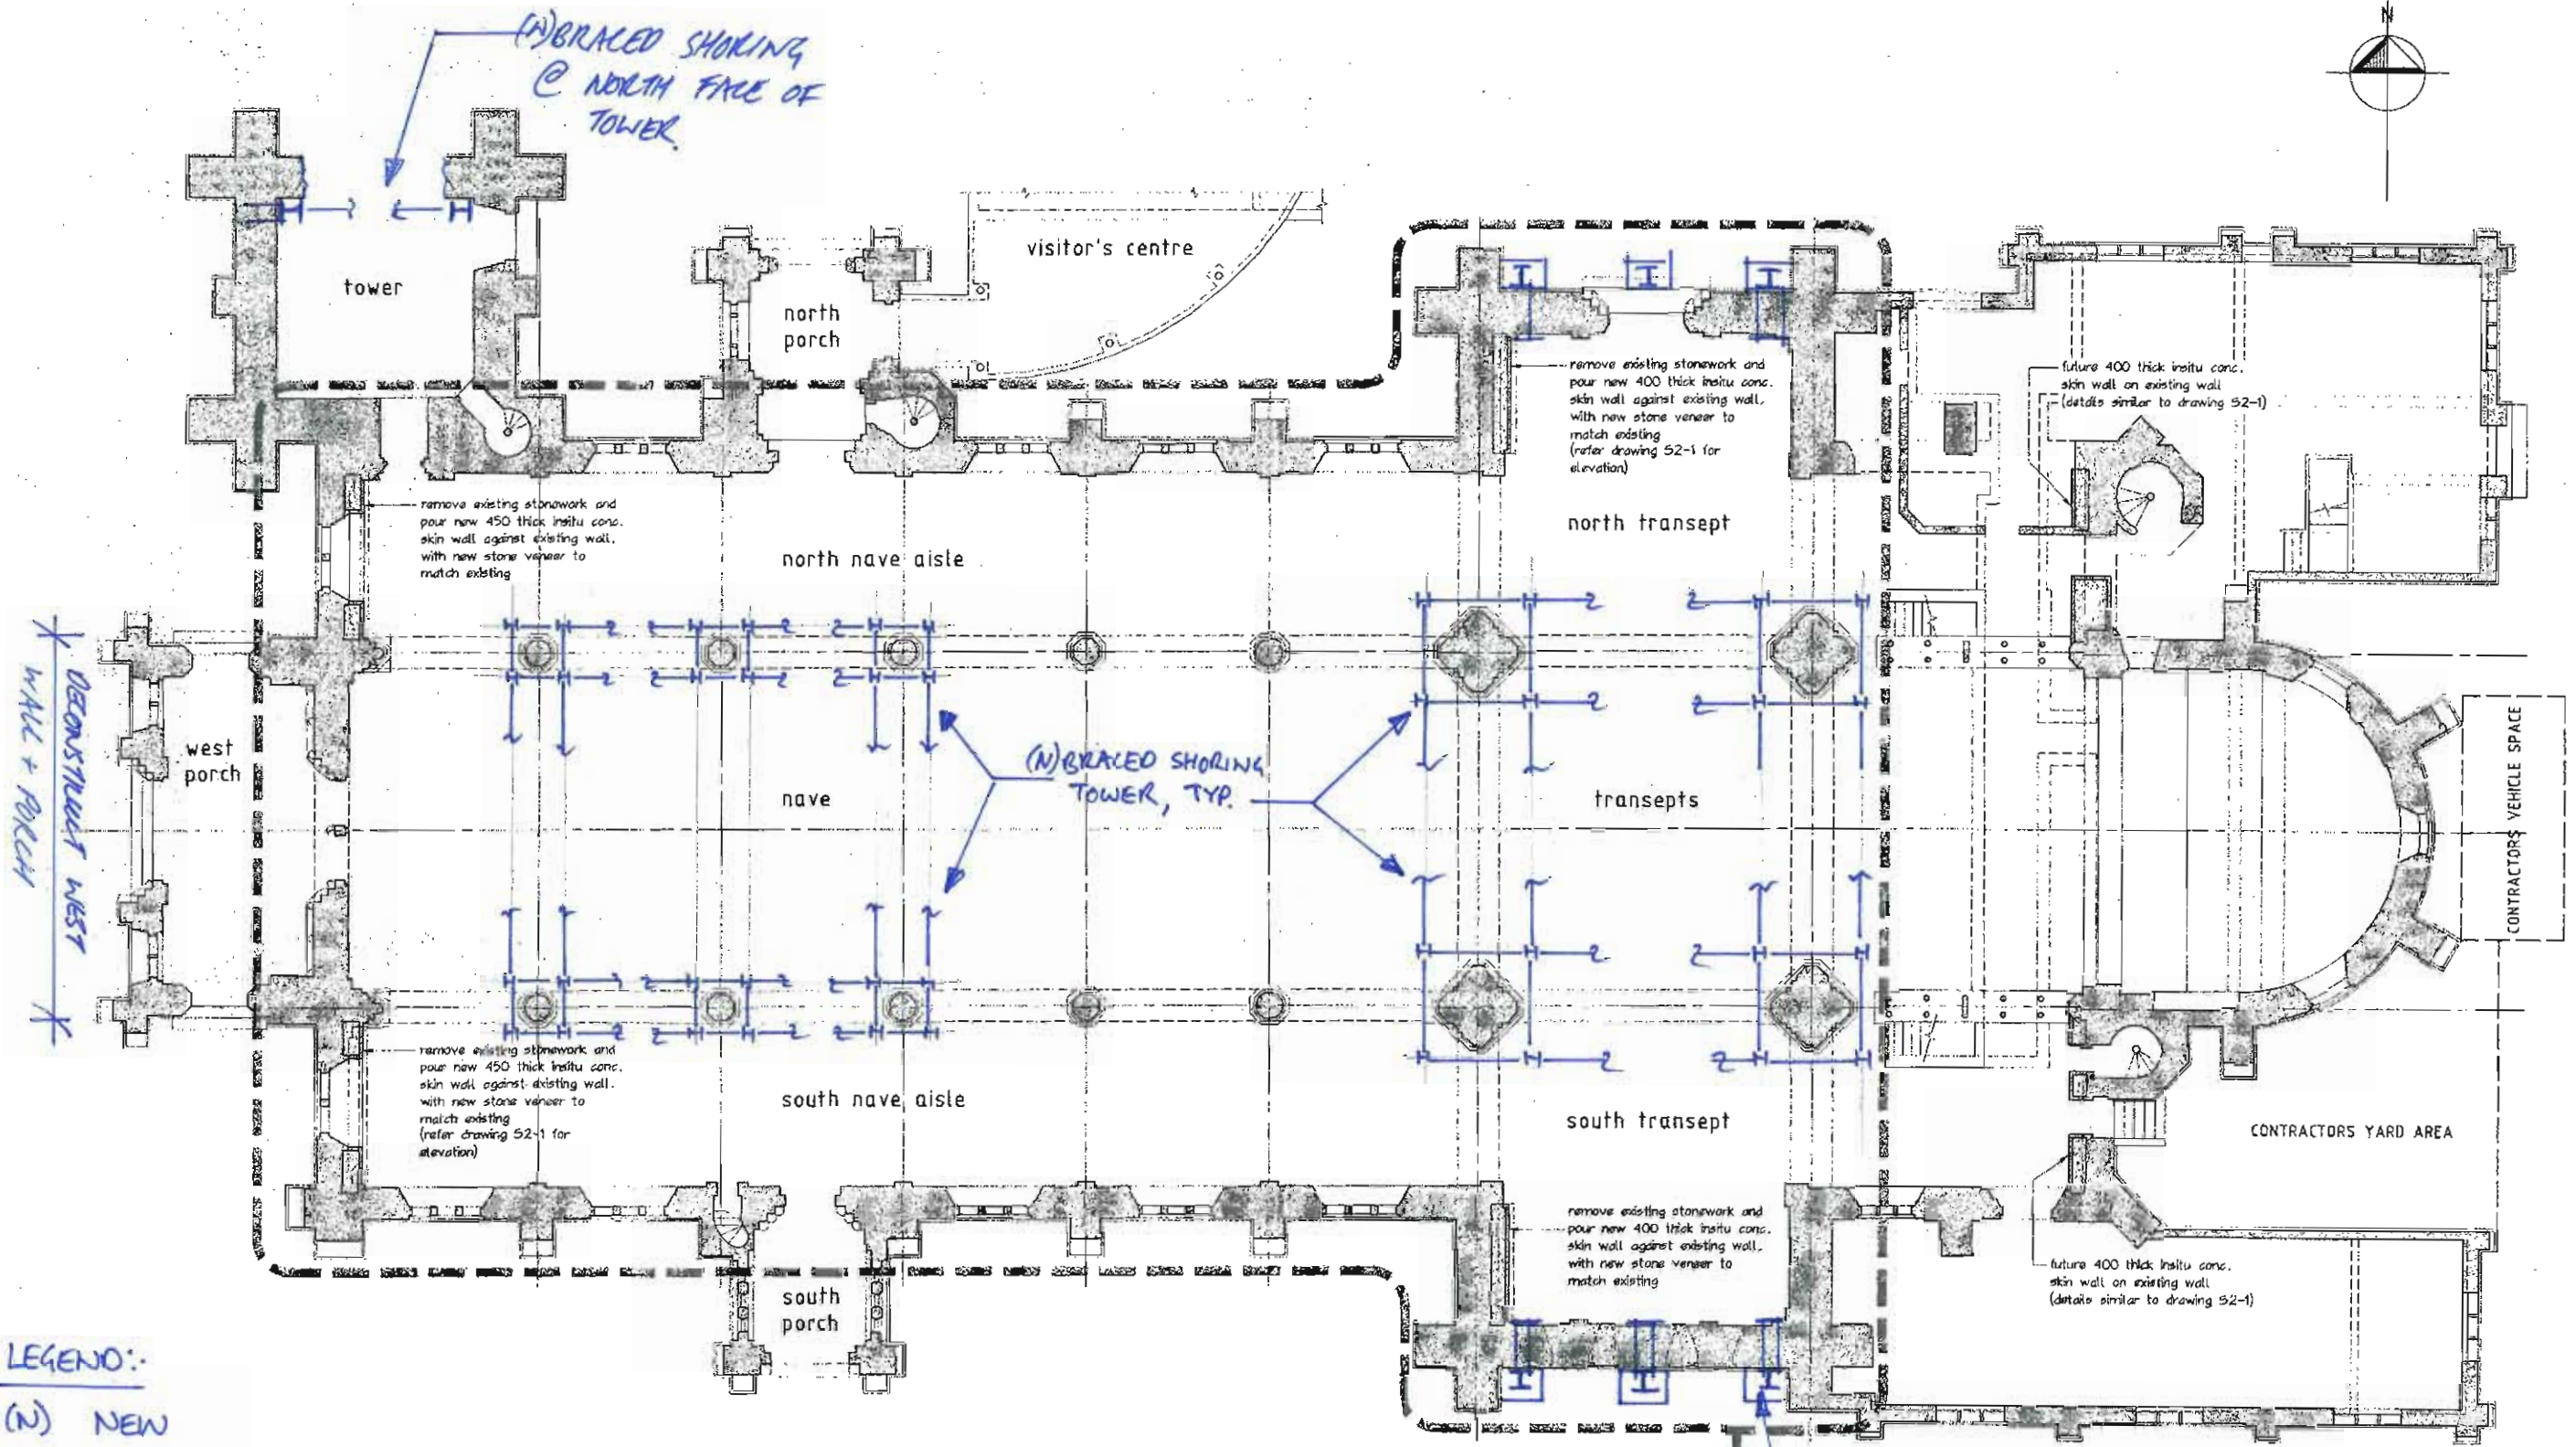
ground floor plan 1:100

(E) DAMAGED PIERS TO REMAIN IN PLACE

(N) ROOF BRACING TO REPLACE (E) DAMAGED BRACING IN THIS BAY.

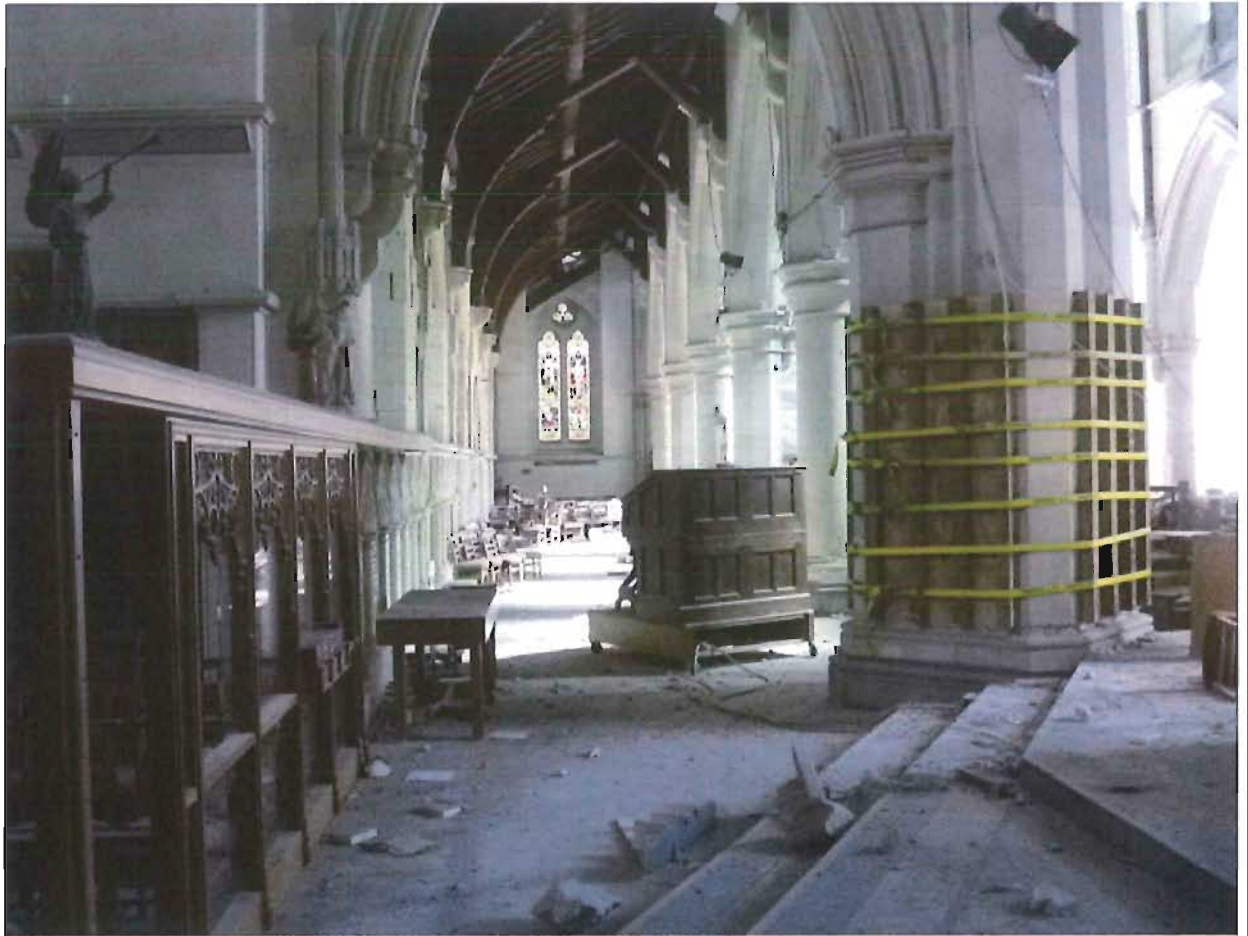
Photograph A – interior view of south exterior foundation and south row of column foundations

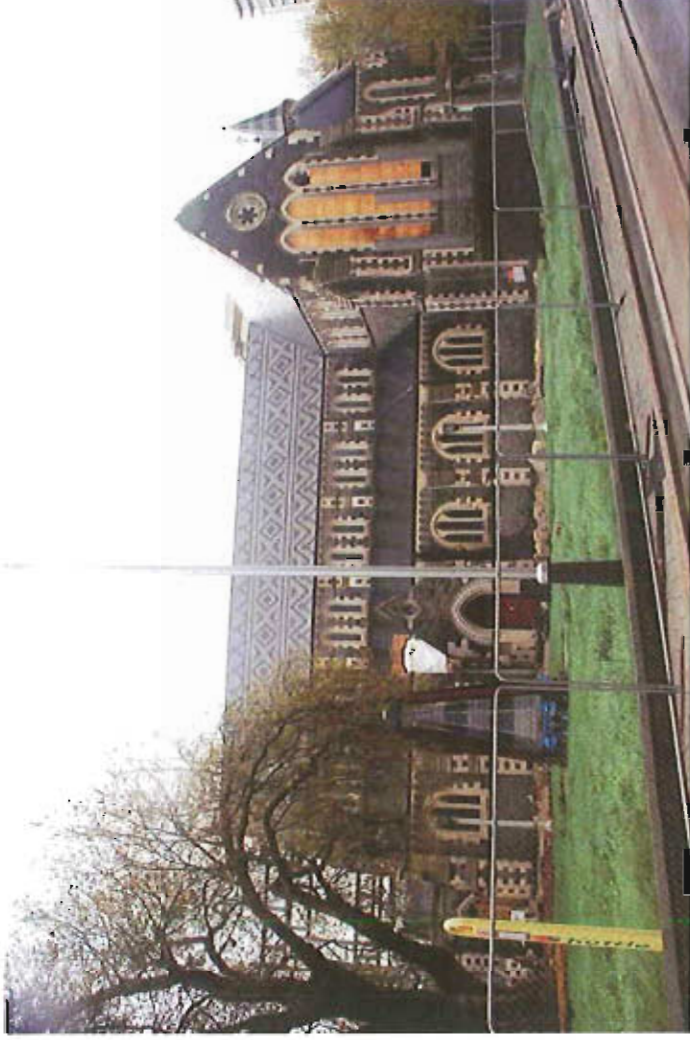
The slate coverings to the main roof slopes have largely remained in place and appear to be generally in good condition. The principal areas of damage are where parts of the structure (such as the west gable and spire/tower) have moved or collapsed. There are some areas, for

example the curved roof of the apse, where raised lines in the slates indicate disturbance of the roof structure/sarking below. Generally, the main ridge cappings and valley gutters remain intact and functional.

Figure 1 General view of the north roof slopes.

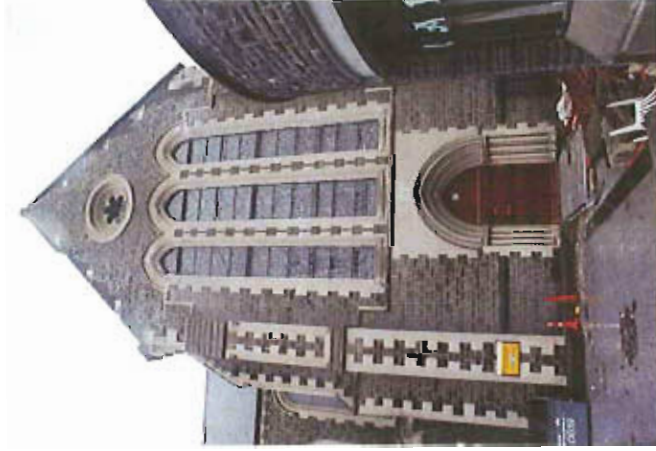
In some instances, essentially to the west gable and parts of the tower, the windows have been destroyed. The majority do however remain, albeit with varying degrees of damage ranging from apparently little, or no, damage to partial buckling or loss. The large window to the south transept has been boarded up and it is understood that the leaded lights are in safe storage following repairs. The stained glass leaded lights to the large north transept window had been replaced before the February earthquake and appears to have survived with little damage, although there is no outer protective glazing now.

Figure 4 The large north transept window.

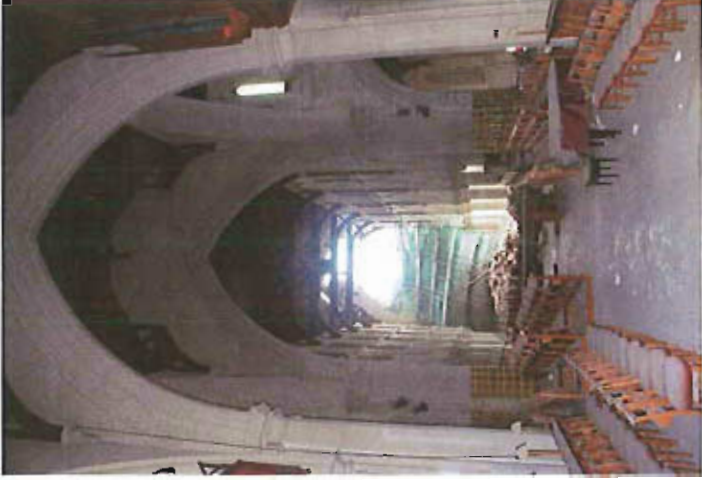
Figure 7 A general view of the nave and crossing floor.

Although the ground movement of the earthquakes may not have caused substantial damage to the floor finishes, fallen masonry is likely to have smashed or cracked many of the floor tiles. Repairs and renewals will no doubt be necessary, but are unlikely to be particularly problematical.

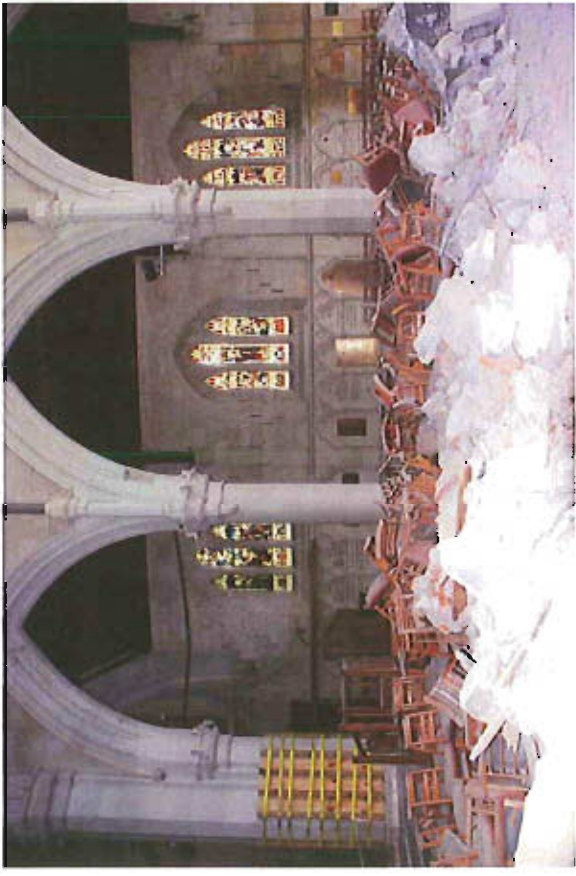
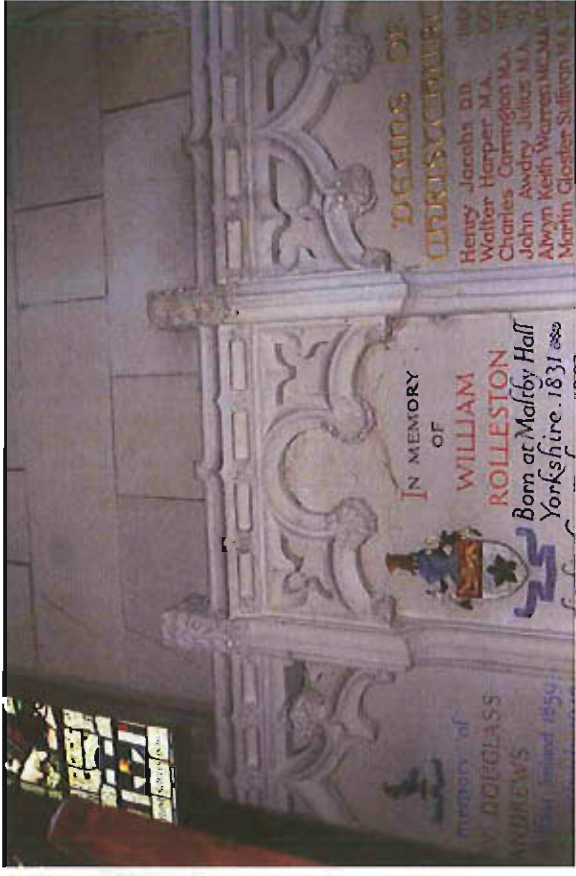
- Small columns to north and south walls of the chancel
A number of these small circular columns have broken off or displaced and will need to be repaired.

- North and south aisle decorative stone panels
The south aisle panels/memorials could only be seen at distance across the nave, but show little signs of damage, the principal fracturing being in the Oamaru stone between the aisle windows. The panels at the east end of the north aisle could be inspected at close hand and are in good condition with only one or two small fractures evident.
